SERVICE BULLETIN NO. 125**Loose bolts and nuts on transformer 20800024**

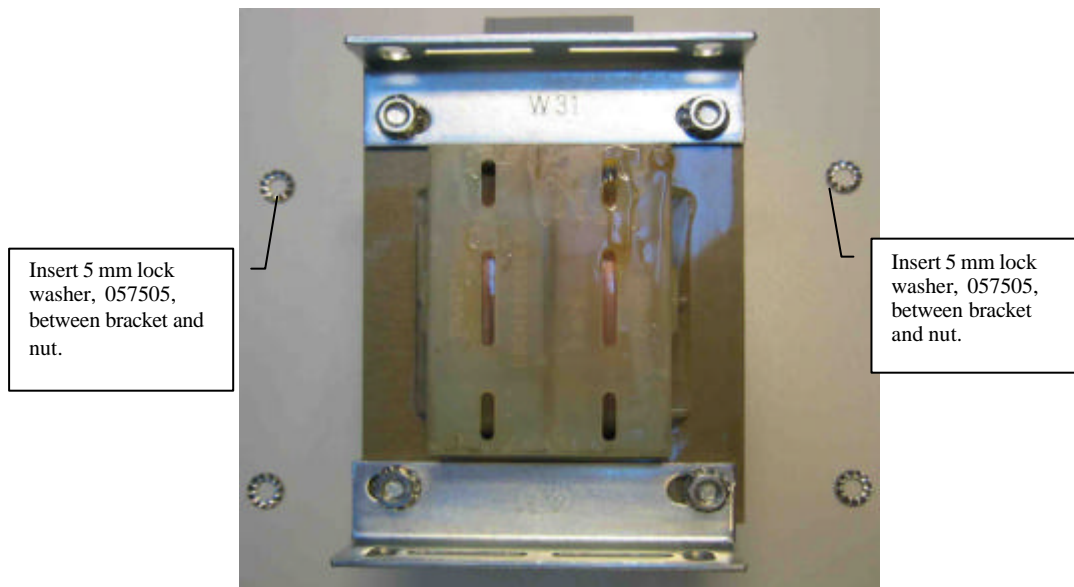
It has come to our notice that on transformer 20800024 the bolts and nuts come loose during operation. We have notified the supplier who will insert self-locking nuts to prevent the problem from arising again.

Service engineers who encounter this fault in the field should insert 4 x 5 mm fan-type lock washers, part No 057505, between bracket and nut.
