## SERVICE BULLETIN NO. 146

### Visual Cooking PT-100 temperature sensors Replacement of plug connections

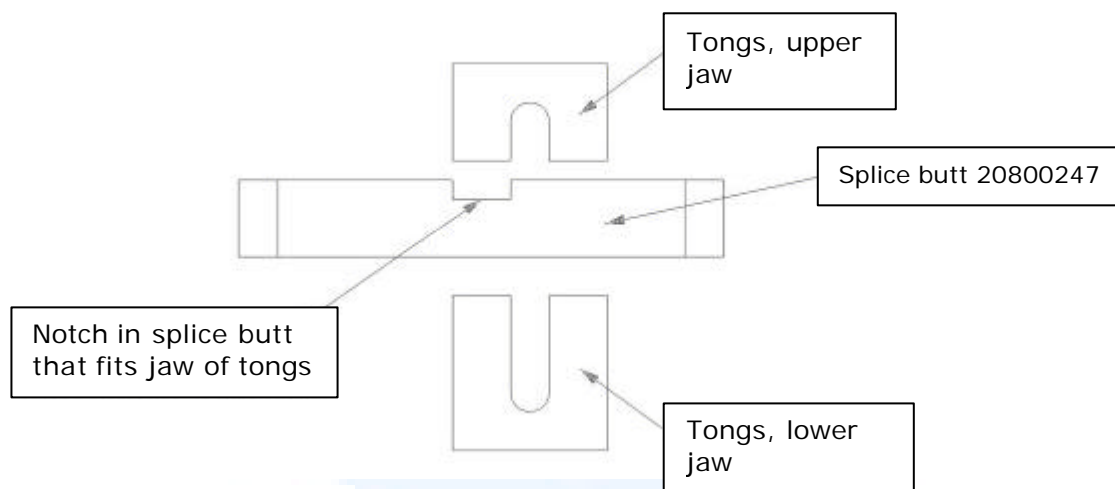
**Consequently, these plug connections have been replaced by splice butts which are squeezed onto the wires as shown below. The part No. of the splice butt is 20800247.**

Of course, the splice butts can also replace plug connections on ovens in operation.
