## SERVICE BULLETIN NO. 178

## **Catch VCI**

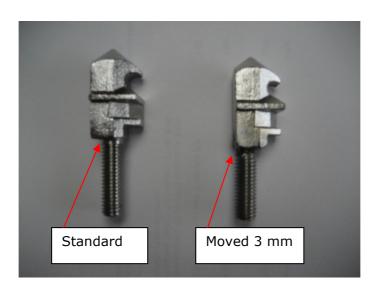
It turns out that when you replace the handle on Visual Cooking I ovens with the new handle for Visual Cooking II (30420013), it is not possible to move the catch far enough to the right.

To solve the problem, you can order a catch (20400267) whose thread has been moved 3 mm.
