**SERVICE BULLETIN NO. 167****Handle for Visual Cooking I**

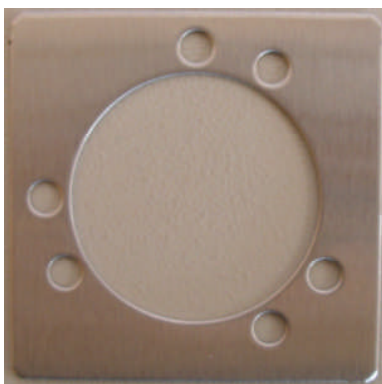
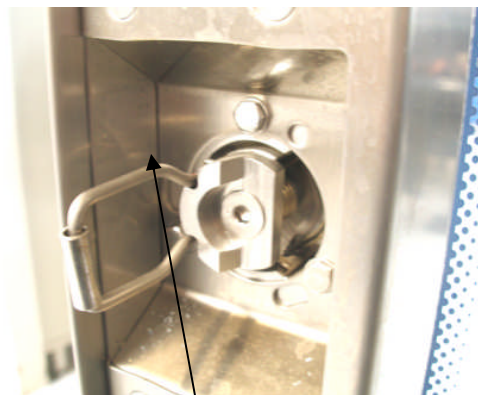
We have experienced that the handle for Visual Cooking I ovens may work loose after some time. One of the reasons for this is that the holes in which to fix the handle are oval. A centering plate (20400266) has now been made to solve the problem.

The edge of the centering plate should touch the door.
