SERVICE BULLETIN NO. 116

Check Valve

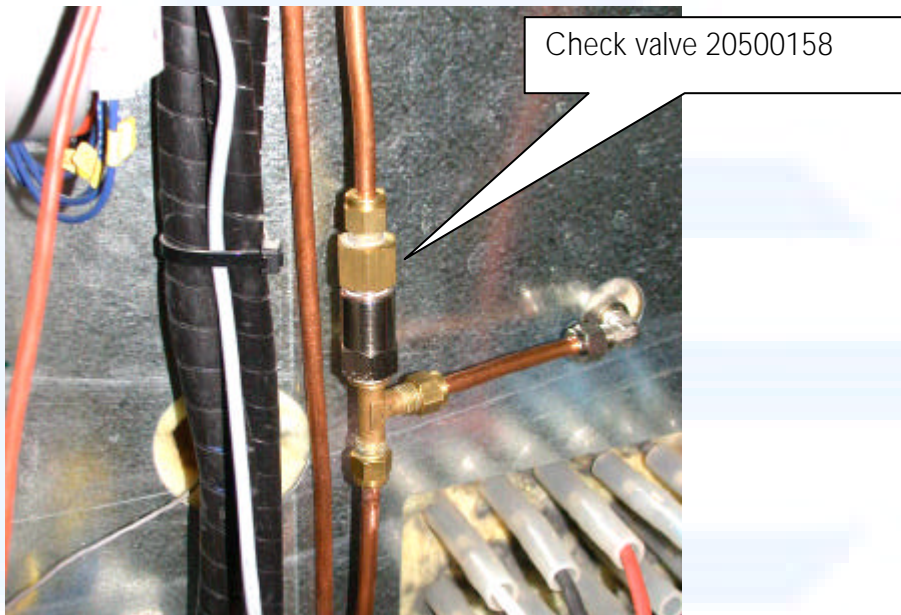
For Visual Cooking model 1.20 CombiClean, we have introduced check valve No. 20500158, the purpose of which is to ensure that the detergent from the upper jet does not run back. The location of the valve is as shown below.

The upper jet is located so that detergent is sprinkled upwards towards the roof, the lower jet so that water is sprinkled downwards.

The new valve was introduced on 1st April 2005
